Manhole Inspection Summary

Manhole # S49C__016MH

Insp Date: **6/11/08 11:19 AM**

Location Address: **rear 146 n lakewood ave**

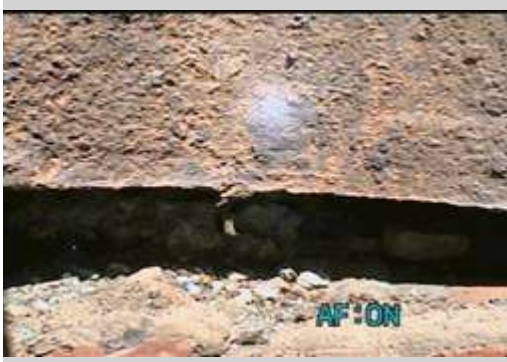
Miscellaneous

Chimney loose bricks,
frame adj

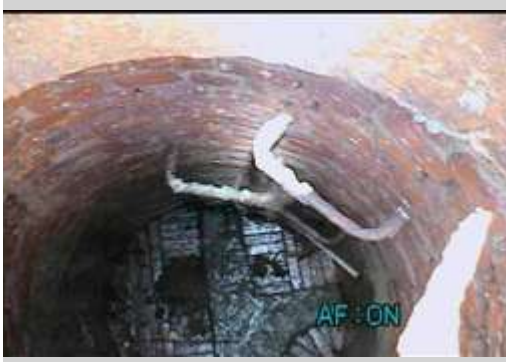
Defect 4

Count: **5** Missing: **0** ☒ **Corroded**

steps

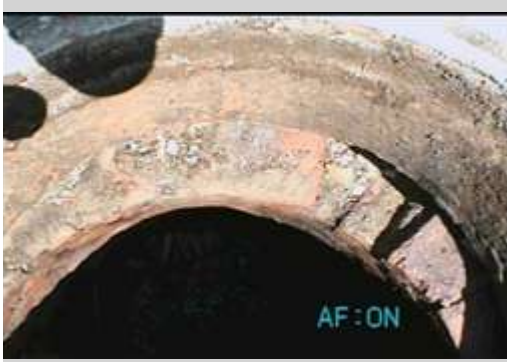
Defect 3

Offset: **4** (in.)

offset

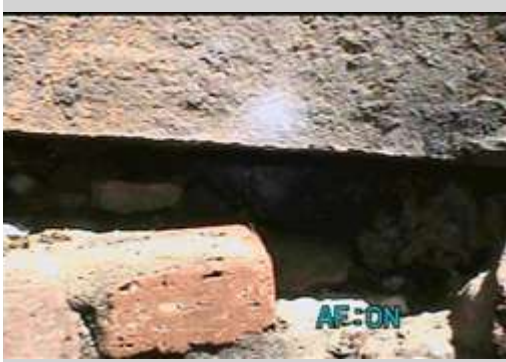
Defect 1

Condition: ☐ Sound ☐ Cracked ☐ Root Intrusion ☒ **Loose Brick** ☐ Deteriorated

corbel condition loose bricks,

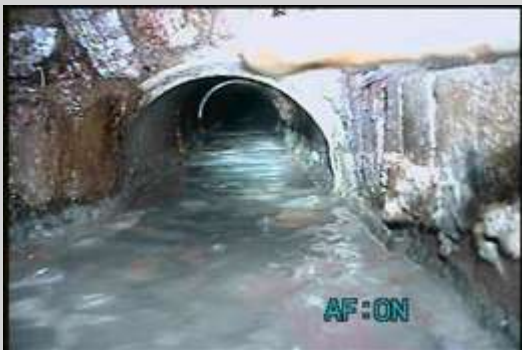
12 O'Clock Outflow

8 in. Circular Gravity Sewer
Drop Out @ 12 O'Clock

Invert Depth: 10.62 (ft.) Flow Characteristics: Fast

Infiltration: None Pipe Seal Cond: Unknown

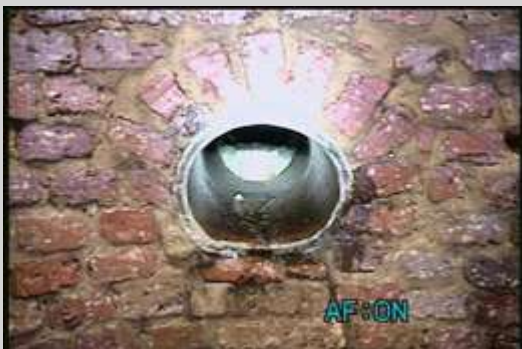
6 O'Clock Inflow

8 in. Circular Gravity Sewer
Pipe In @ 6 O'Clock

Invert Depth: 9.06 (ft.) Flow Characteristics: Fast

Infiltration: None Pipe Seal Cond: Unknown

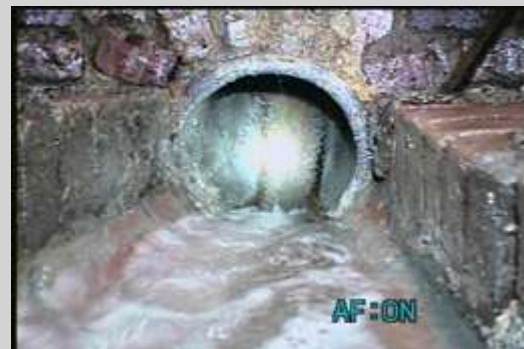
Drop In @ 6 O'Clock

Drop: Outside Direct

Inv Depth: 10.61 (ft.)

Drop Condition: Open

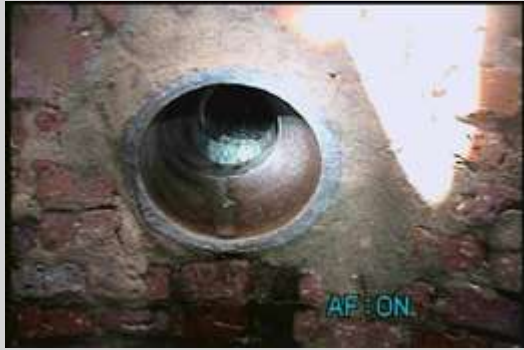
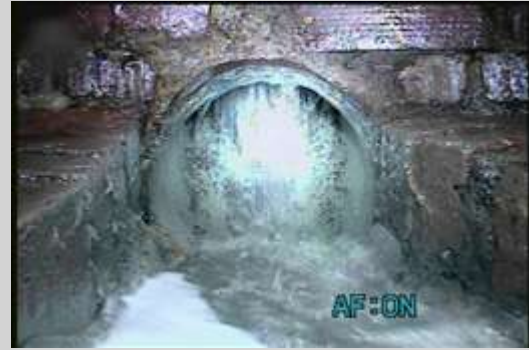
9 O'Clock Inflow

8 in. Circular Gravity Sewer

Pipe In @ 9 O'Clock

Drop In @ 9 O'Clock

Invert Depth: **5.96** (ft.) Flow Characteristics: **Fast**

Drop: **Outside Direct**

Drop Condition: **Open**
